1 / THE RESTORATION OF THE EXTERIOR

MARIE-THÉRÈSE VAN THOOR

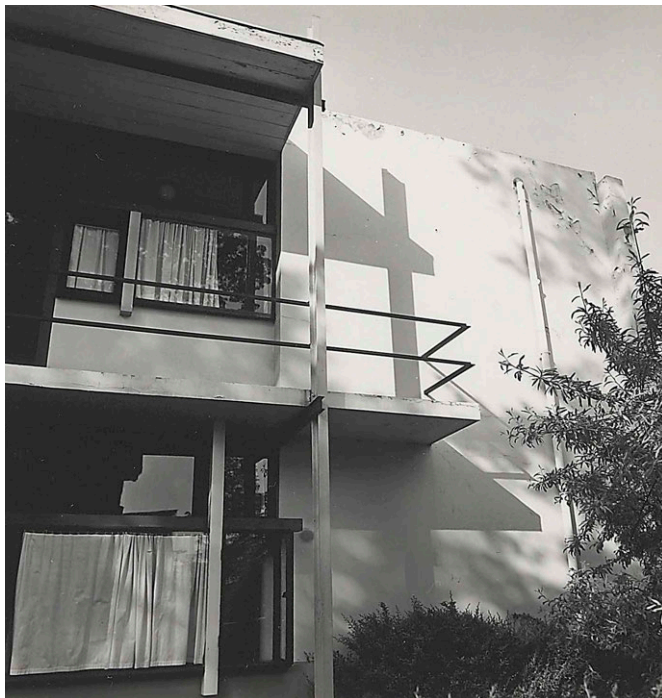
FIG. 1.2 Damage to the house became increasingly visible

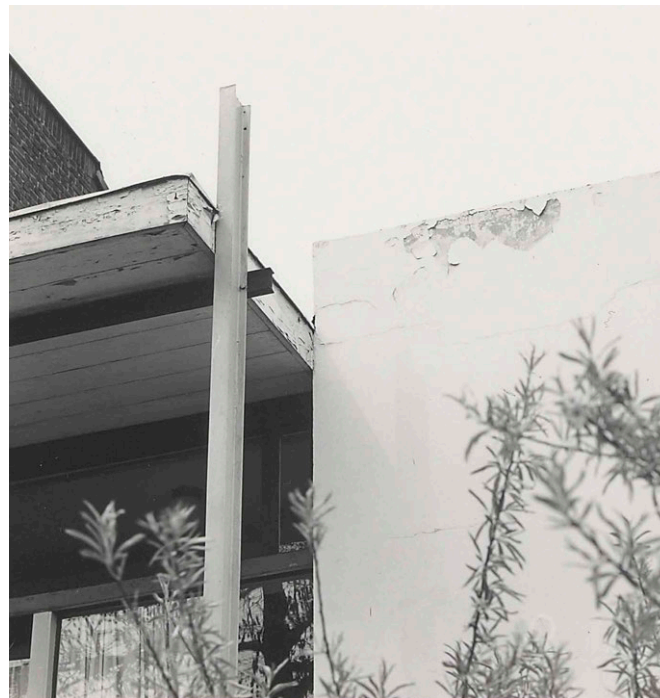
FIG. 1.3 Plasterwork and wood exhibited serious blemishes

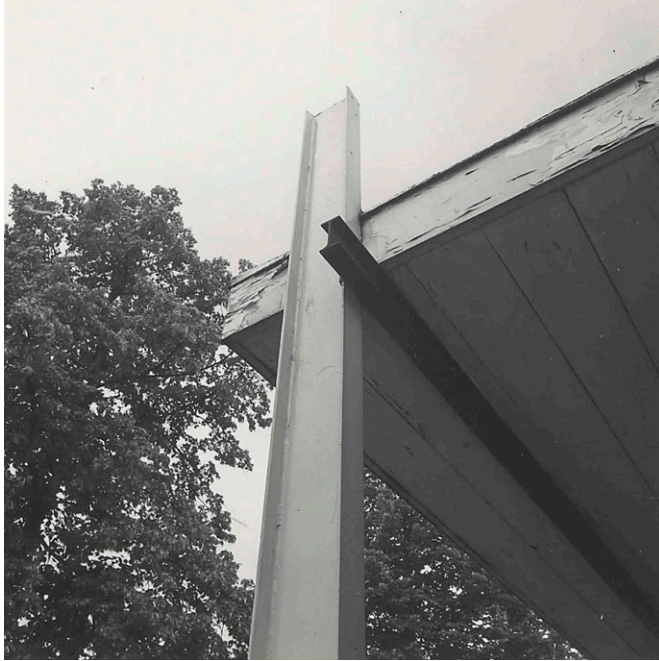
FIG. 1.4 Unconventional constructions made the house vulnerable

This was mainly because Rietveld considered the spatial effect and associated appearance, and the optical effect, more important than a stable and sound construction [FIG. 1.4]. This had resulted in unusual combinations of traditional and modern materials (and their properties) and techniques which, after the passage of so many years had started to exhibit all manner of defects. For example, the way the steel beams had been tailed into the (single-skin) brickwork had led, through the action of moisture, to rust and hence to cracks in both brickwork and plaster. At Rietveld's insistence, the concrete slabs used for the balconies had to be very thin so that here, too, moisture had been able to corrode the steel edges, which had started to rust, and the concrete had begun to display cracks [FIG. 1.5].

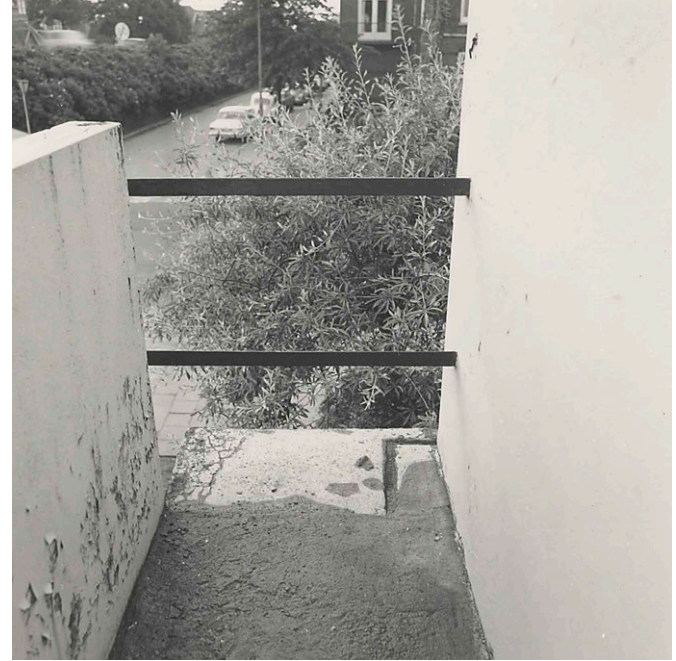
FIG. 1.5 After 50 years the concrete of the balconies also showed signs of cracks and damage

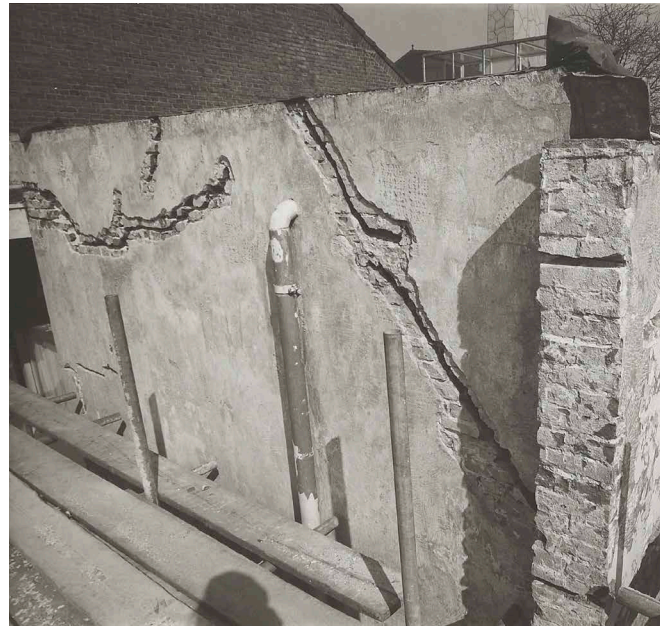
The restoration of the exterior was carried out between March and September 1974. The cracks in the plasterwork were mainly in the east and south elevations and once that plaster had been chipped away cracks were also discovered in the brickwork behind it [FIG. 1.9].²⁹ The Stichting Onderzoek en Voorlichting (Foundation for Research and Information, SOV) of a firm specializing in plastering, terrazzo and plasterboard (STS) had been asked for advice and in February it had provided detailed instructions for the repair and treatment of damaged sections of brickwork and plaster, for the joints between plasterwork and wood, and for the concrete. SOV's J.F. (Hans) Geerken provided advice on the method as well as on the specific composition of the materials to be used. In accordance with this advice, Mulder

FIG. 1.9 The brickwork displayed deep cracks

had the cracks in the brickwork treated with a synthetic mortar that was then coated with a synthetic dispersion to ensure that the rendering coat would adhere. Where the cracks were only in the plasterwork, the mortar layer was re-rendered and then plastered to the same level as the existing plasterwork, on which the existing layers of paint were still present. Instead of applying a fine render to the base coat, Rietveld had the plasterer impart texture directly to the (hardened) rendering coat. The circular motion of the trowel produced a grainy effect.³⁰ Geerken saw to it that the various stages of this work were carried out according to instructions.

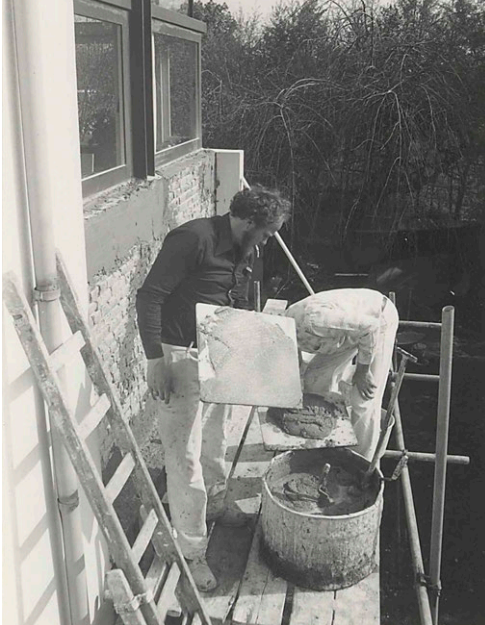
FIG. 1.10 Plasterers at work on the wall between corner window and kitchen

Work started at the end of April and after the removal of the layer of mortar it was discovered that the repairs to the brickwork using synthetic mortar had held up well. The substrate was homogeneous, and according to Geerken the brickwork was of reasonably good quality.³⁹ Thus the problems lay with the rendering. Even more radical decisions were then taken on site. 'The render that had remained in place during the restoration also had to be removed in order to achieve a single homogeneous plaster coat and to avoid problems with joins between old and new work [FIG. 1.10/1.11].'⁴⁰ Whether this literally meant that all the
