3 / RESTORATION OF THE INTERIOR

MARIE-THÉRÈSE VAN THOOR

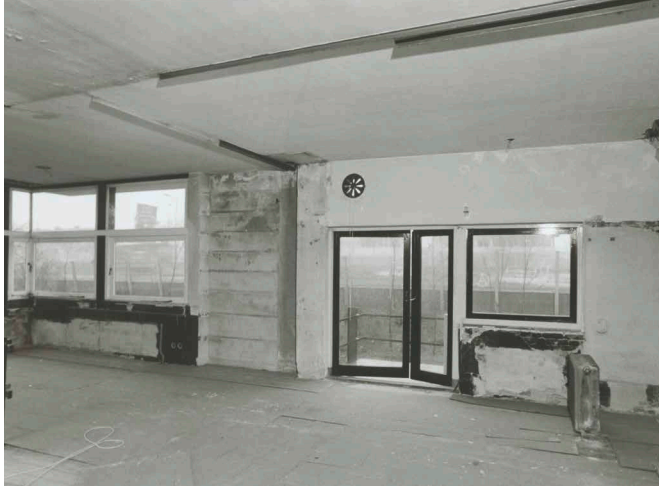
FIG. 3.3 The partially dismantled upper floor

The most visible and radical aspect of the restoration of the upper floor was the stripping of the walls and ceiling, the elements that were so crucial to the spatial picture [FIG. 3.3/3.4]. Stripped back they revealed only 'bare brickwork' and a bare soffit [FIG. 3.5/3.6/3.7]. 'The [foundation] and I were of the opinion that we would only be able to make the original spatial picture clearly and definitely tangible if the delimiting surfaces that determine that picture were once more of impeccable texture and colour,' Mulder later wrote. Even the possible withdrawal of the RDMZ's grant did not persuade the foundation to change its mind according to Mulder.²³ In 2016 Mulder still recalled a visit to his office by Ida van Zijl and Wim Denslagen. There was further discussion of the rigorous approach, which according to Denslagen did not correspond to what RDMZ was used to. Mulder explained once more that for him the original spatial experience went hand in hand with the restoration of space and surfaces. 'Denslagen disappeared, and that was the end of it'.²⁴ And so Mulder proceeded to reprise the reconstructive approach he had previously applied to the exterior.

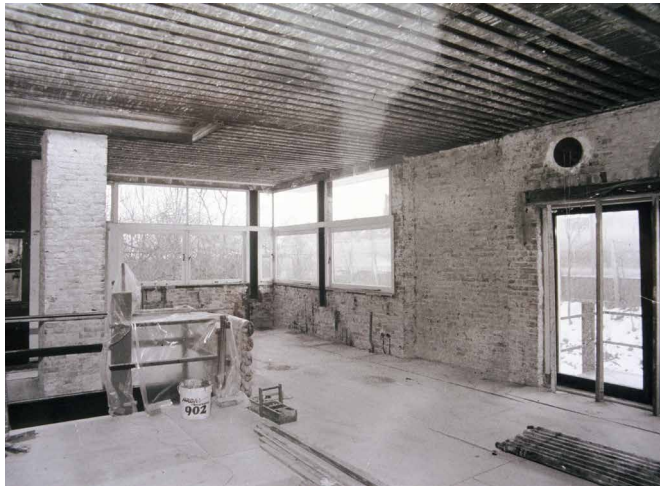
FIG. 3.5 The upper floor of the Rietveld Schröder House in dismantled state

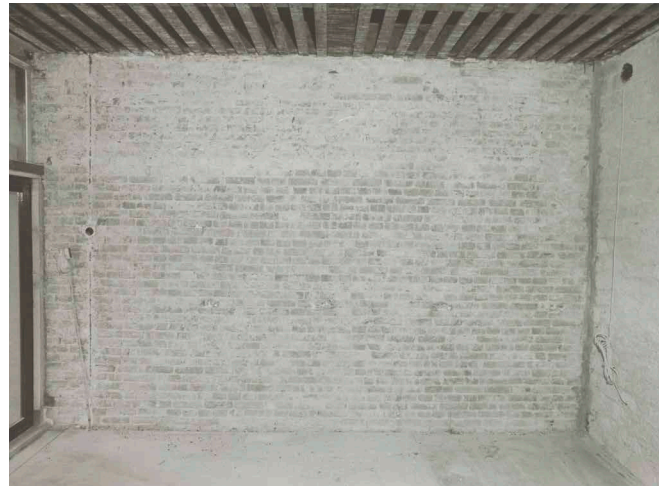
FIG. 3.6 Bare brick wall and stripped ceiling

Before the walls were replastered, the cracks in the brickwork were, like those in the exterior, filled with synthetic mortar. The new metal lath ceiling was suspended from the joists using a (floating) steel network in order to minimize the chance of cracks.²⁷ The plastering was carried out by the firm of H. van de Kant Afbouwbedrijf Zeist B.V. H. van de Kant recalled that the existing plaster had to be carefully removed and placed in bags in plastic trays, sorted according to wall area and colour. This enabled Mulder to carefully examine the plaster and layers of paint on top of it.²⁸ After that examination the old plaster was carried away and destroyed. Although the abovementioned memos from 1984 and 1985 refer to a specific plaster mix, Mulder and Van de Kant stated, when asked, that the exact proportions of cement, sand and lime were decided on site. Ultimately, it was the plasterer who determined this, just as in Rietveld's day. After applying the plaster, the plasterers had to sand the base coat 'with jute on a wooden board', to achieve the same effect as under Rietveld. It resulted in a smooth surface with here and there a stray grain of sand, but without any traces of repair work or restoration.

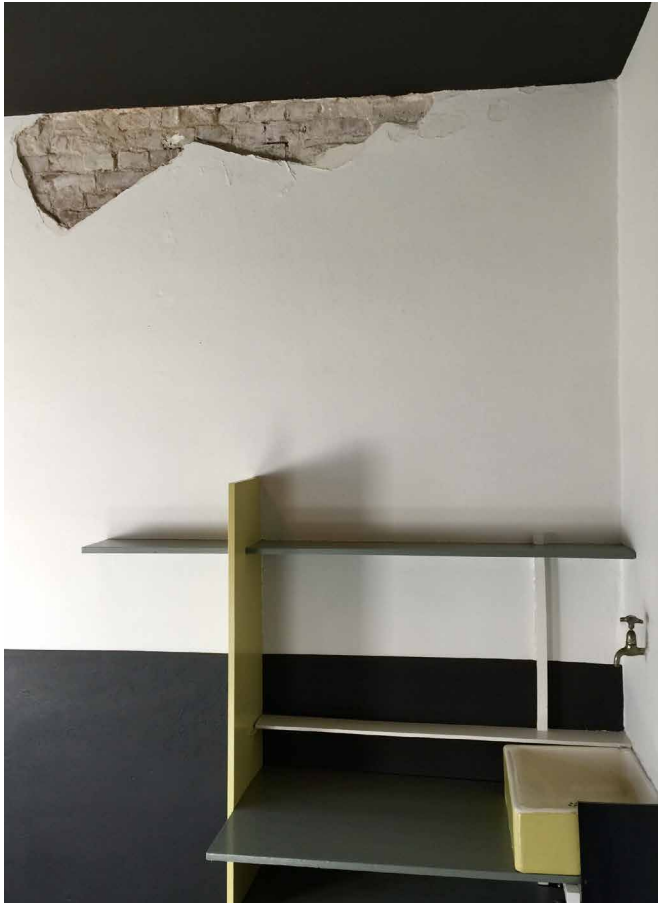
FIG. 3.13 The plasterwork at the top of the south wall of the study was damaged and came loose in October 2016

In October 2016 a piece of plaster came loose at the top of the south wall of the study [FIG. 3.13]. This provided an opportunity to have both the cause of the loosening and the composition of the plaster investigated by, respectively, TU Delft and TNO.³⁶ Quite by chance it was possible to show a sample of this plaster to Hans Geerken, who had been involved in the restoration of the exterior. He thought it looked as if it had been composed of coarse sharp sand from Buslo with putty lime and cement; he thought the sand dated from the 1970s. In addition, the top layer of paint was probably Alfatex IQ latex.³⁷ Thus it looked as if the plasterwork on this wall had been renewed. However, TNO's petrographic analysis indicated that the sample did not contain any cement and consisted of lime mortar base coats, lime mortar finishing coats plus two top coats. 'It's possible the sample was a fragment of the original plaster,' was TNO's conclusion.³⁸
