# 2 / THE PAINTWORK AND THE COLOURS OF THE EXTERIOR

MARIE-THÉRÈSE VAN THOOR

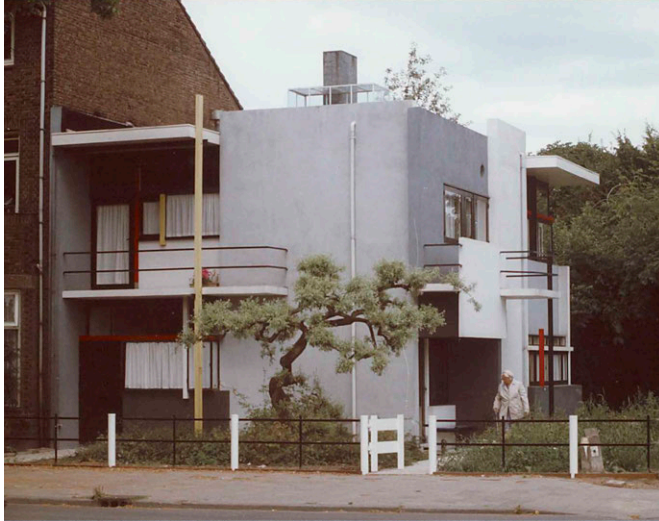
FIG. 2.6 The house in the early 1980s, after the second treatment of the exterior

than ever to find enough walls and elements on the exterior of the Rietveld Schröder House with traces of original layers of paint that would allow the overall colour palette of the house in 'the most original state' to be pieced together [FIG. 2.6].

blue. Mrs Schröder recalled that when she first met Rietveld, many people considered black obtrusive, but according to Rietveld black actually receded into the background. He used it for elements – like door and window frames – that were not intended to obtrude, with the result that everything appears to be in the same plane and the composition is emphasized [FIG. 2.6/2.10].<sup>25</sup>

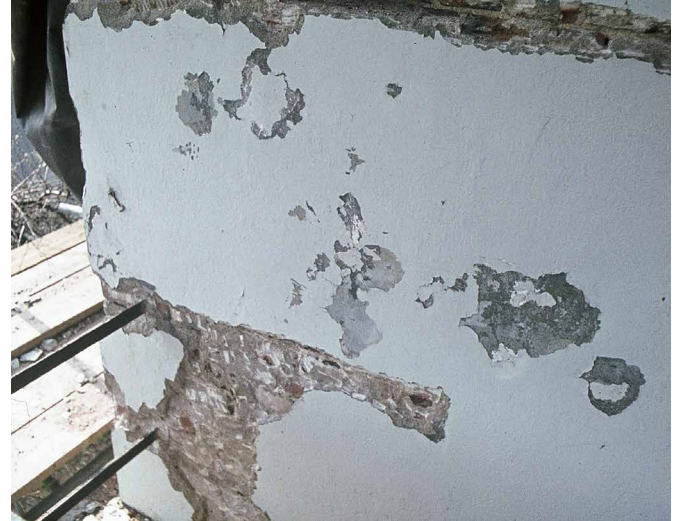
FIG. 2.7 In various places, such as the chimney, B. Mulder found still more finish coats and colours that he could include in his colour research

Despite the fact that the Schröder House had been regularly repainted (possibly as many as ten times), and colour coats had been removed on previous occasions, old paint was evidently still to be found in certain places, such as behind the prickly ivy or on the chimney [FIG. 2.7].<sup>18</sup> Mulder included these remnants in his colour research, and investigated their composition [FIG. 2.8].<sup>19</sup> Once the restoration was finished he threw the samples away.

Upon inquiry Mulder turned out to have yet more information in the form of a series of slides and a set of colour samples.<sup>20</sup> Detail photos of the chimney show various finish coats and it appears possible to distinguish several colours. Even more interesting is a photo of the wall below the kitchen window in the east elevation [FIG. 2.9]. We can see various shades of grey, from light to dark, and between them the white of a base coat. Mulder's caption reads: 'I opted for a dark grey from top right corner.'<sup>21</sup> This is one of the wall surfaces that were not repaired and on which the original plaster is still present, according to Mulder. Nevertheless, we are left guessing about the dates of these grey coats because there is simply no further documentation and also because references to other wall surfaces are lacking. The layers of paint on the walls, which were entirely stripped in 1979, were removed together with the old layers of render.
