5 / INDOOR CLIMATE IN THE RIETVELD SCHRÖDER HOUSE

BARBARA LUBELLI AND ROB VAN HEES

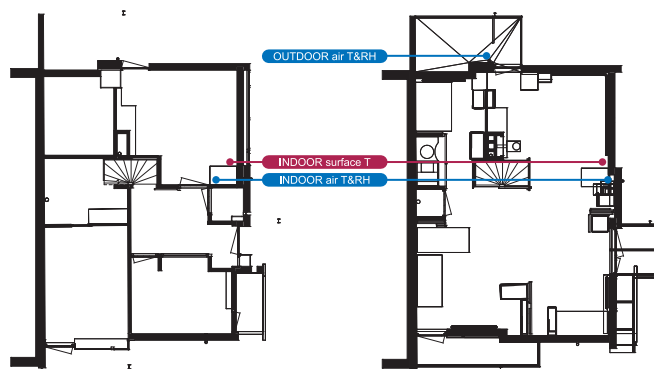
The temperature and relative humidity (RH) of the air on the ground and first floors of the building [FIG. 5.1], were measured at 15-minute intervals for more than a year; additionally, the climates in the skylight and in the basement were recorded for a period of several months. The temperature at the construction surface was monitored for different materials (wood, masonry, steel frame), to assess the risk of surface condensation. The outdoor climate (temperature and RH) was monitored as well.

FIG. 5.1 Location of the sensors on the ground (left) and 1st (right) floor.

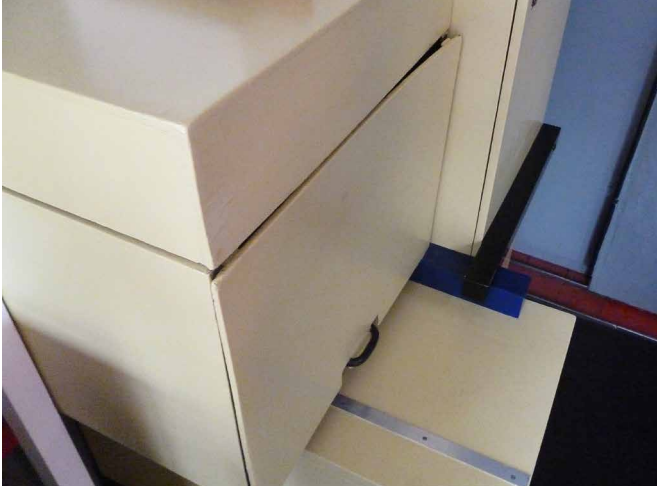
FIG. 5.2 Deformation of thin timber elements of furniture

The state of conservation of the furniture is generally good. However, some pieces of furniture, mainly the thinner parts, are visibly deformed [FIG. 5.2]. Floor finishes (carpet and linoleum) become worn due to use and are regularly replaced.

No immediate risks of biological growth or mechanical damage have been detected. The option of replacing the original pieces of furniture with copies, might still be considered if the lifetime needs to be optimized or when other risks (e.g. mechanical damage caused by visitors) need to be avoided.

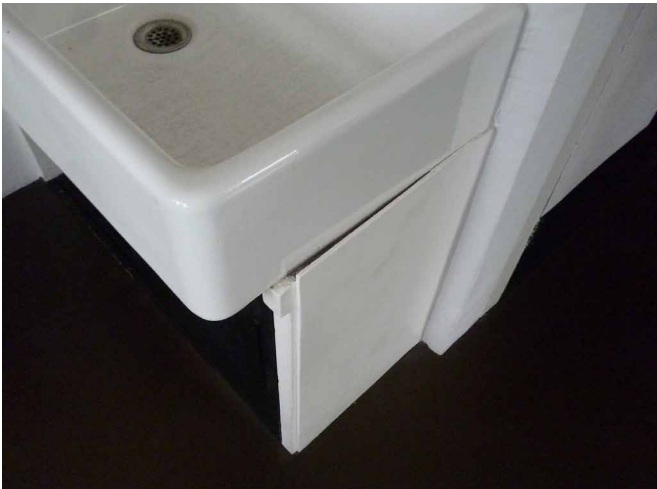
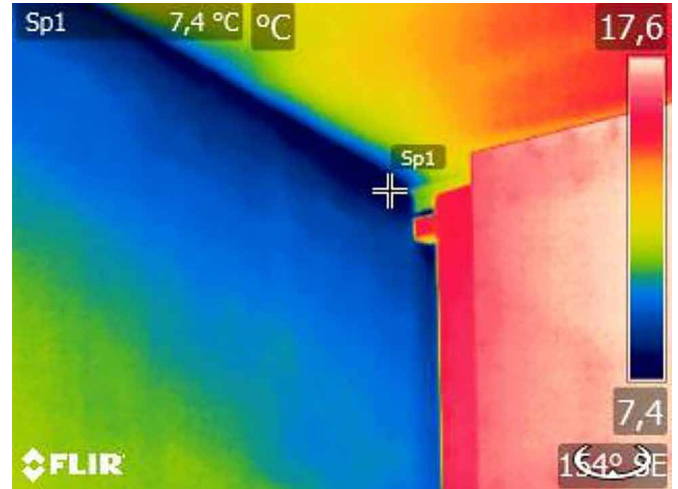
FIG. 5.3 Surface temperature in a corner of the construction, top: IR image, bottom: normal image; the insert shows the plan of the 1st floor with the location (in red) of the inspected area

Thermographic images made it possible to identify thermal bridges in corners and at connections between walls and ceiling in the external envelope of the building [FIG. 5.3].

No immediate risk of biological growth or surface condensation was detected in the present situation. However, as several severe thermal bridges are present in the construction, the risk of mould growth on the construction might arise should interventions like sealing of windows be undertaken without simultaneously introducing RH control.

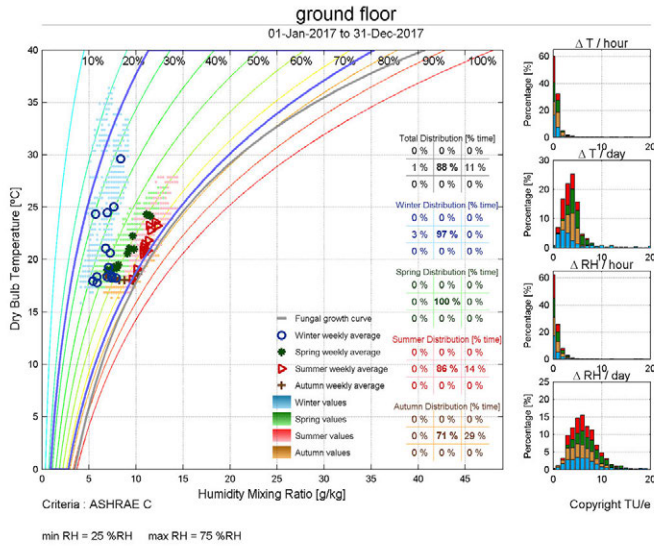
The absence of surface condensation is confirmed by the measurements of the surface temperature and the calculation of the resulting RH at the surface. Despite no surface condensation being detected, high values of air RH (> 80-85% RH) might still lead to biological growth on plaster and wooden surfaces in the event of extended periods of high RH; in addition, variations in RH and temperature might lead to risks for the conservation of the building materials and furniture. These risks are further examined. First the correspondence of the indoor climate to the specifications for ASHRAE climate control class C, which is the expected class, was assessed. Figures 5.8 and 5.9 show that, when considering RH specifications, 88% and 98% (for the ground floor and first floor respectively) of RH values are within the given criteria for class C. In summer and autumn, there is still a significant percentage of values which exceeded the RH requirements; this percentage is higher for the ground floor than for the first floor. No risk of fungal growth was detected. A few temperature values exceeded 30 °C (due to malfunctioning of the heating system), while a significant number of values exceeded 25°C in the spring and summer period (mostly on the first floor). For climate control class C, according to the ASRHAE guidelines,⁸ risks of mechanical damage are mainly present for highly vulnerable objects and for paintings, some books and some artefacts [TABLE 5.2]. However, as the ASRHAE does not further specify which type of artefacts, and the indoor climate does not fully meet the specifications for class C, it is difficult to draw conclusions as to the risks for the conservation. Another approach, which considers the response of the material to the indoor climate,⁹ was therefore adopted (see above). Table 5.3 reports the outcome of this elaboration, performed using the web tool at <http://www.monumenten.bwk.tue.nl/>.

FIG. 5.8 Temperature and RH data recorded on the ground floor of the building in 2017 compared to the specifications for class C; graphical elaboration performed using the web tool available at <http://www.monumenten.bwk.tue.nl/>

Based on these results it is possible to conclude that the indoor climate is safe as far as the wooden furniture is concerned; neither biological growth (germination and growth of spores) nor mechanical damage are to be expected. However, the lifetime multiplier (LM), is relatively low, especially for the ground floor, which means that the service life is lower than it would be in ideal conditions (stable 20 °C and 50% RH).

Based on the results of the monitoring, it is suggested that the indoor temperature and RH level be monitored, and an alarm system used so as to be able to intervene promptly in case of malfunctioning of the heating system.

In order to reduce RH in the summer, air dehumidification should be considered. Ventilation will not be sufficient, as the absolute outdoor humidity during summer is high.

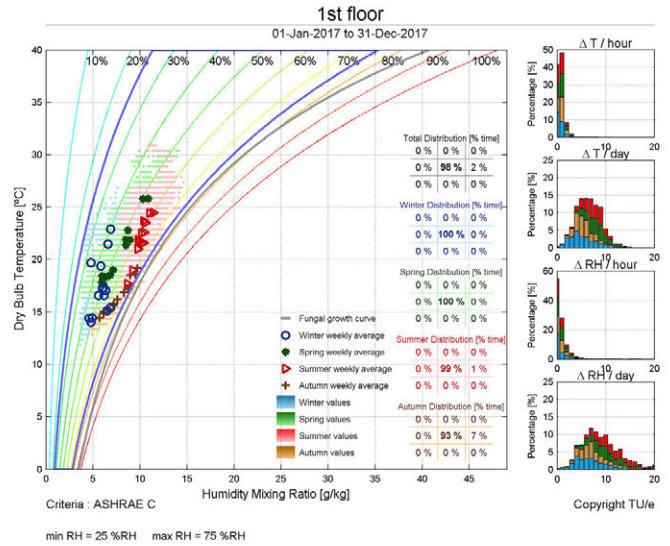
FIG. 5.9 Temperature and RH data recorded on the first floor of the building in 2017 compared to the specifications for class C; graphical elaboration performed using the web tool available at <http://www.monumenten.bwk.tue.nl/>

During the heating season, periods with higher than desirable temperatures and lower than desirable RH values were recorded, mainly due to a malfunction of the heating system. During the summer season, very high RH values were recorded.

The indoor climate of the building falls largely within the ASHRAE class of control C, which can be considered the class of control possible for this building (uninsulated masonry, single-glazed windows, heating without RH control). The risk to the furniture of mechanical damage and biological growth is low.
