1 / THE RESTORATION OF THE EXTERIOR

MARIE-THÉRÈSE VAN THOOR

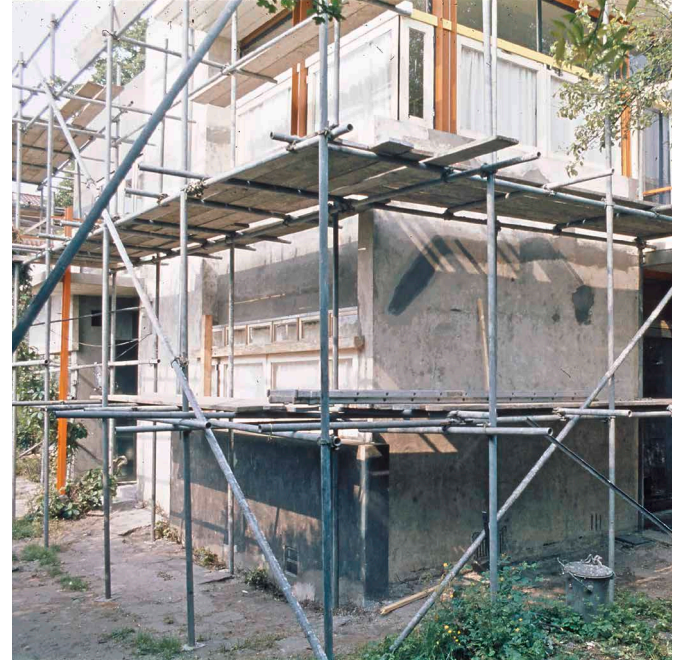
FIG. 1.8 Although the house was surrounded by scaffolding, Truus Schröder continued to live in it during the restoration of the exterior
